Name Of Dam: SWIFT CREEK RESERVOIR DAM  
Location: CHESTERFIELD COUNTY  
Inventory Number: VA. 04112

# PHASE I INSPECTION REPORT

## NATIONAL DAM SAFETY PROGRAM

**DEWARD M. MARTIN & ASSOCIATES  
WILLIAMSBURG, VIRGINIA  
AUGUST, 1979**

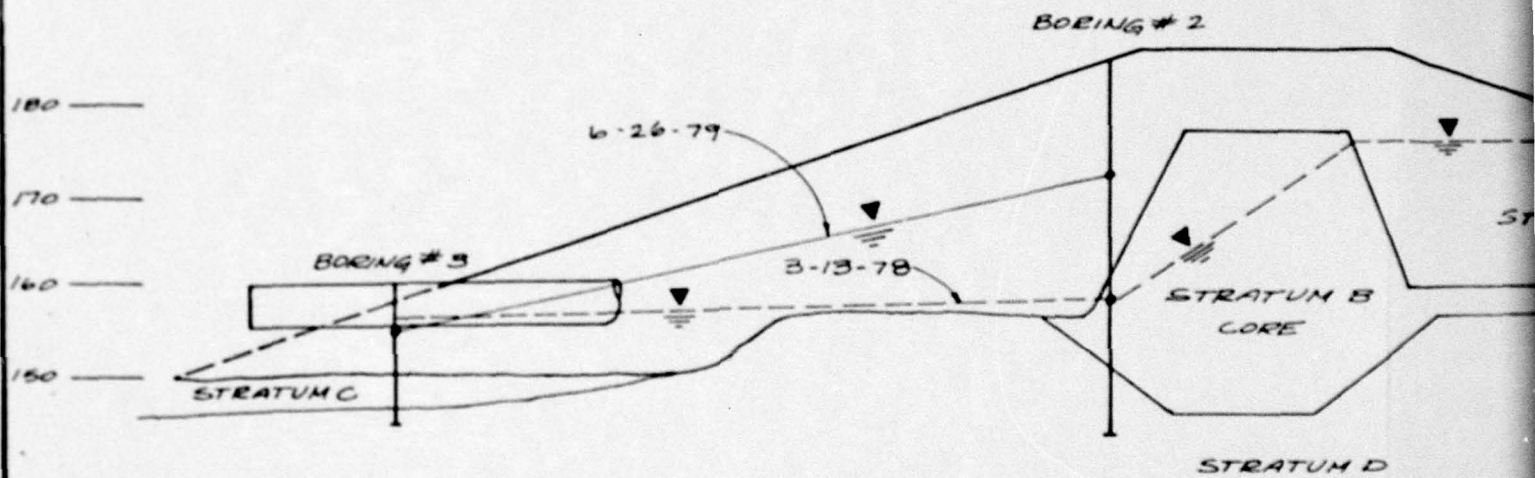
# PLATE NO. 1

During the present site inspection, water level readings were taken in two observation wells, B-2 located at the crest of the dam and just downstream of the core, and B-3 located just downstream of B-2, at the toe of the dam. The water level readings taken on June 25, 1979 (Plate 1, Appendix III) indicated either the core wall is not functioning or the pool elevation is above the core and water is following a line of seepage above it.

Water level readings taken in 1978 indicated the core was functioning properly. Plate 1 in Appendix III is a typical cross-section of the dam taken at the observation well locations, and shows the two approximate lines of seepage.

WATER LEVEL READINGS	
	3-13-78	6-26-79
BOEING # 2	25' 10"	12' 0"
BOEING # 3	2' 9"	4' 6"
